Rehabilitation Techniques for Stripped Asphalt Pavements

Final Report

STATE OF MONTANA
DEPARTMENT OF TRANSPORTATION
RESEARCH AND DEVELOPMENT PROGRAM

December 2002

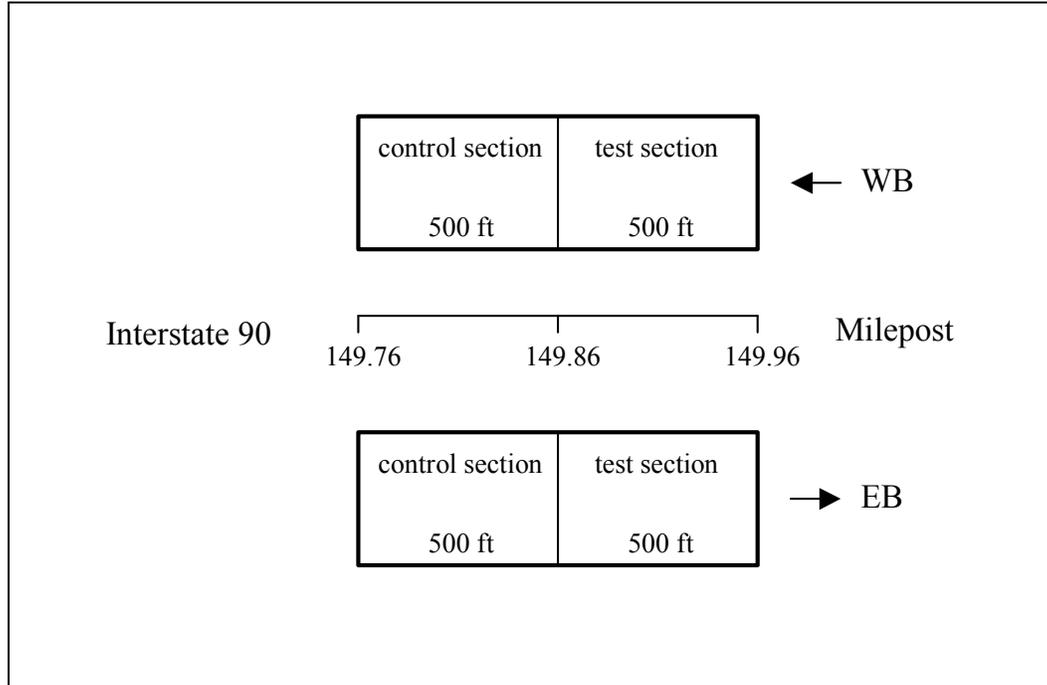
Figure 2. Layout of the Test Site at Bearmouth-Drummond

The Bearmouth-Drummond test site is located on Interstate 90 in Granite County, just west of Drummond, Montana. The site includes both a control and a test section in each of the eastbound and westbound lanes, as shown in Figure 2. Each control section is west of each test section. Each control section is 500 feet long, starting at milepost 149.76 (STA 842+81.9) and ending at milepost 149.86 (STA 847+81.9). Each test section is also 500 feet long, starting at milepost 149.86 (STA 847+81.9) and ending at milepost 149.96 (STA 852+81.9). A one-inch diameter steel rod was placed at the beginning and end of the control and test sections on the north side of the westbound lane, along the right-of-way fence.

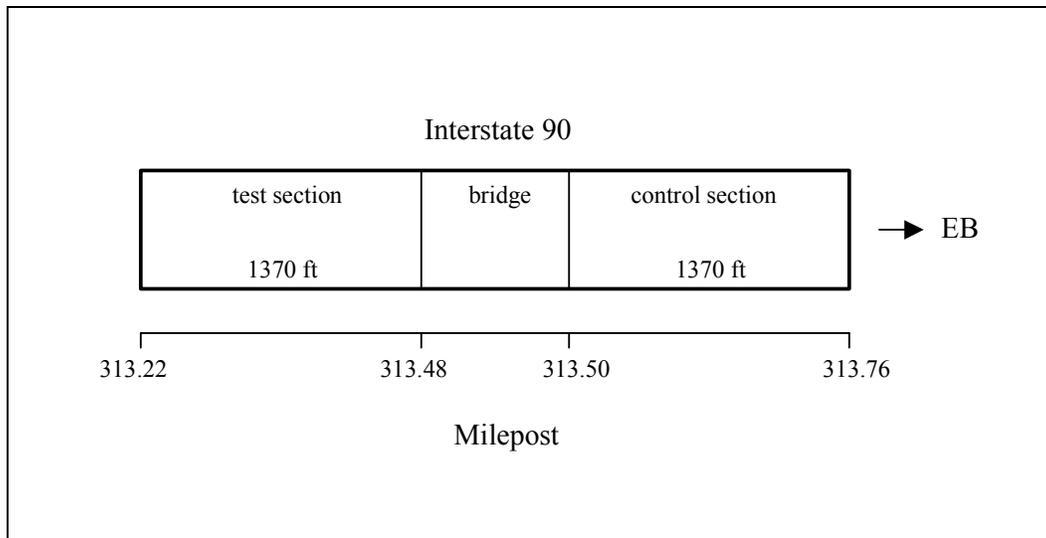
Figure 3. Layout of the Test Site at Rocky Canyon

The Rocky Canyon test site is located on Interstate 90 in Gallatin County, just east of Bozeman, Montana. Both the control and test sections are in the eastbound lane, separated by the bridge at the Bear Canyon Interchange (Figure 3). The test section is west of the bridge, while the control section is east of the bridge. The test section is 1370 feet long, starting at milepost 313.22 (STA 218+77.3) and ending at milepost 313.48 (STA 232+47.7). The control section is also 1370 feet long, starting at milepost 313.50 (STA 233+60.7) and ending at milepost 313.76 (STA 247+30.7). A one-inch diameter steel rod was placed at the beginning and end of the control and test sections on the south side of the eastbound lane, along the right-of-way fence.

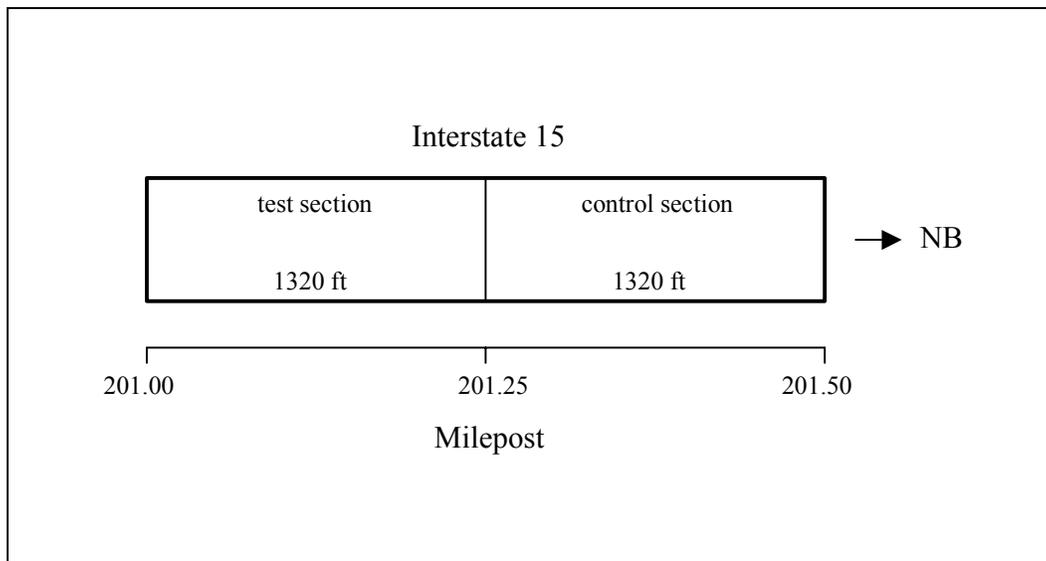
Figure 4. Layout of the Test Site at Lincoln Road-Sieben

The Lincoln Road-Sieben test site is located on Interstate 15 in Lewis and Clark County, just north of Helena, Montana. Both the control and test sections are in the northbound lane, as shown in Figure 4. The test section is south of the control section. The test section is 1320 feet long, starting at milepost 201.00 (STA 667+50) and ending at milepost 201.25 (STA 680+70). The control section is also 1320 feet long, starting at milepost 201.25 (STA 680+70) and ending at milepost 201.50 (STA 693+90). A one-inch diameter steel rod was placed at the beginning and end of the control and test items approximately twenty feet off the shoulder.

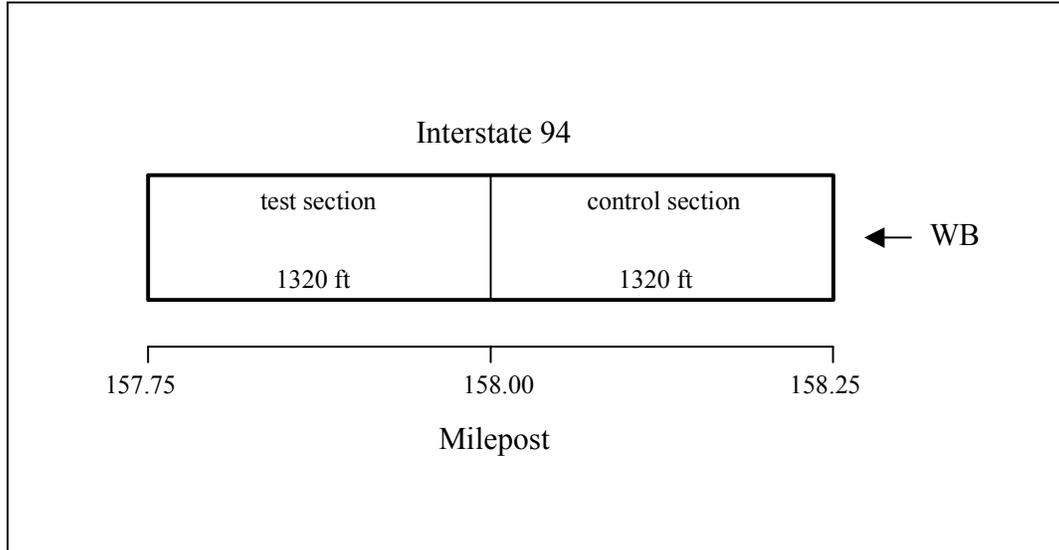
Figure 5. Layout of the Test Site at Custer County Line West

The Custer County Line West test site is located on Interstate 94 in Custer County, approximately fifteen miles east of Miles City, Montana. Both the control and test sections are in the westbound lane, as shown in Figure 5. The test section is west of the control section. The test section is 1320 feet long, starting at milepost 157.75 (STA 439+39) and ending at milepost 158.00 (STA 452+59). The control section is also 1320 feet long, starting at milepost 158.00 (STA 452+59) and ending at milepost 158.25 (STA 465+79). A one-inch diameter steel rod was placed at the beginning and end of the control and test items approximately fifty feet off the shoulder.

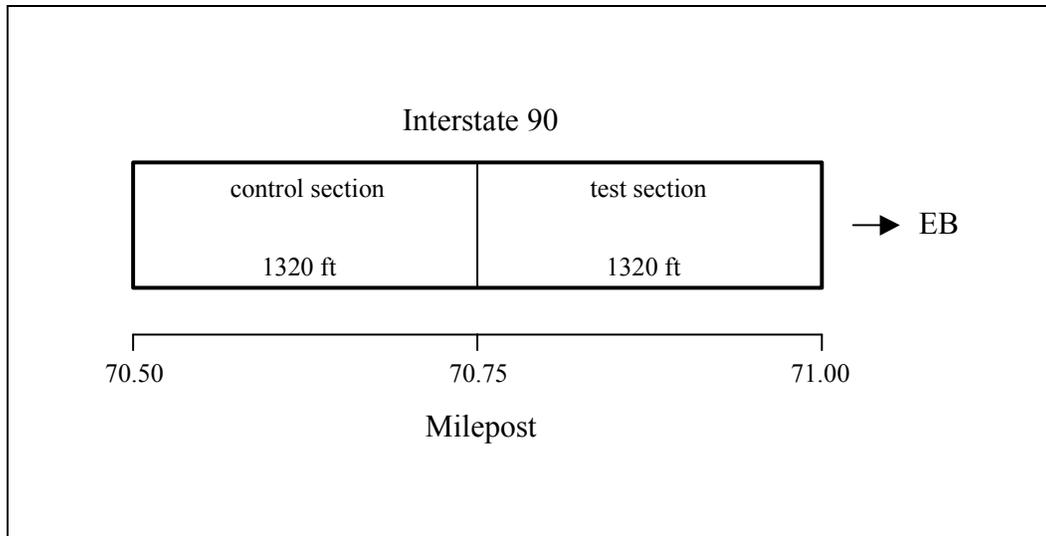
Figure 6. Layout of the Test Site at Tarkio-East

The Tarkio-East test site is located on Interstate 90 in Mineral County, just east of Tarkio, Montana. Both the control and test sections are in the eastbound lane, as shown in Figure 6. The control section is west of the test section. The control section is 1320 feet long, starting at milepost 70.50 (STA 627+18.1) and ending at milepost 70.75 (STA 668+60). Test section is also 1320 feet long, starting at milepost 70.75 (STA 668+60) and ending at milepost 71.00 (STA 681+80). A one-inch diameter steel rod was placed at the beginning and end of the control and test items approximately ten feet off the shoulder.

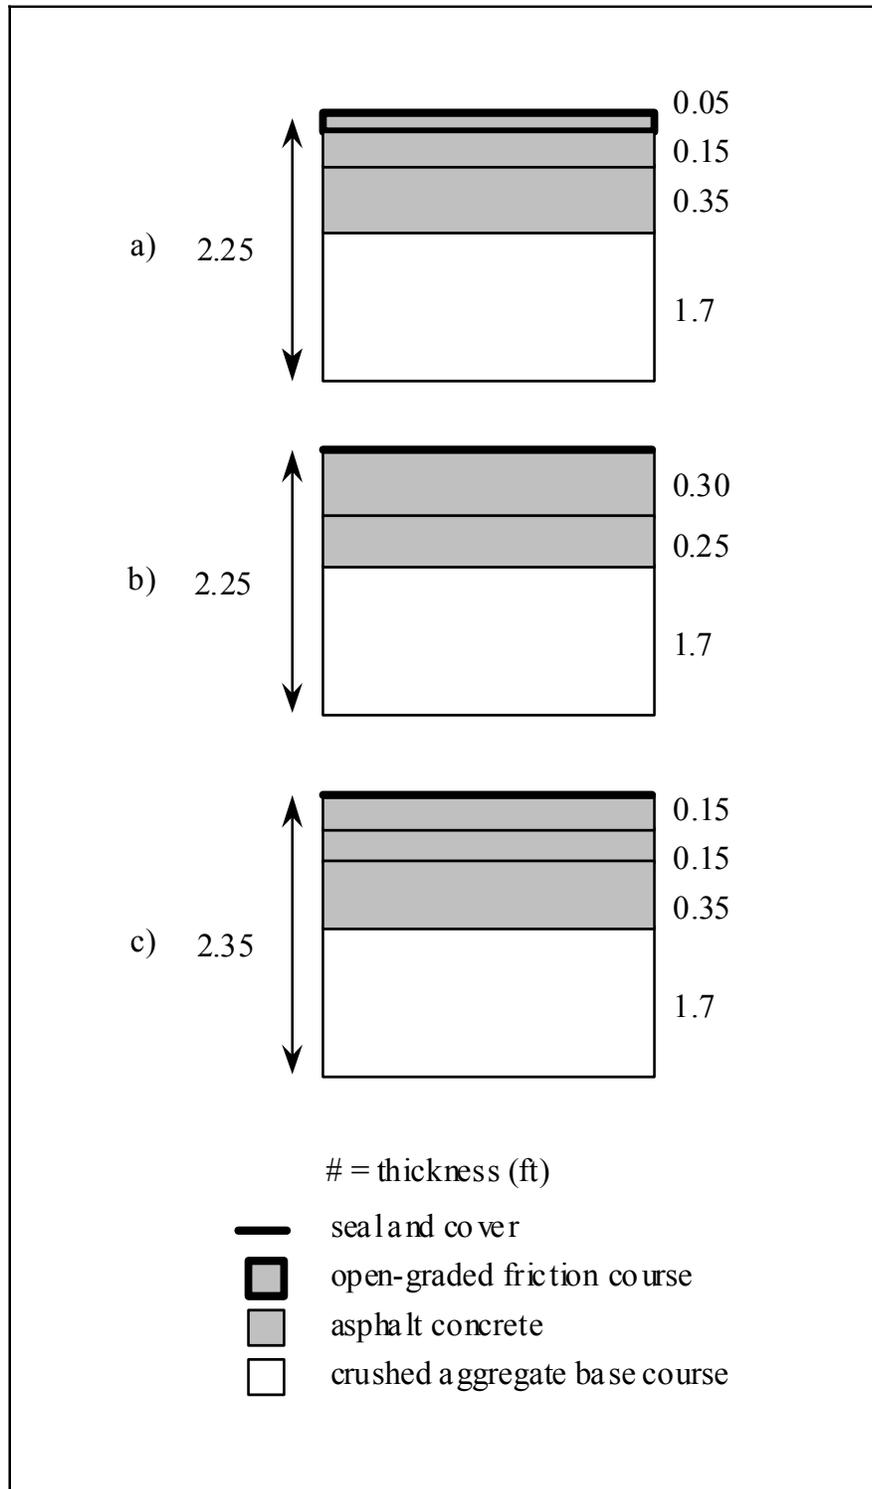
Figure 7. Pavement Cross-Sections at Bearmouth-Drummond:
a) original pavement, b) control section, and c) test section

The structural capacities of the test sections at all sites were increased relative to the original pavement structures. Milling was only deep enough to remove the OGFC, so all overlay lift thicknesses were greater than the depth of removed material. Increases in total thickness above subgrade for the test sections ranged from 1 to 4 inches, as shown in Table 8 and Figures 7 through 11.

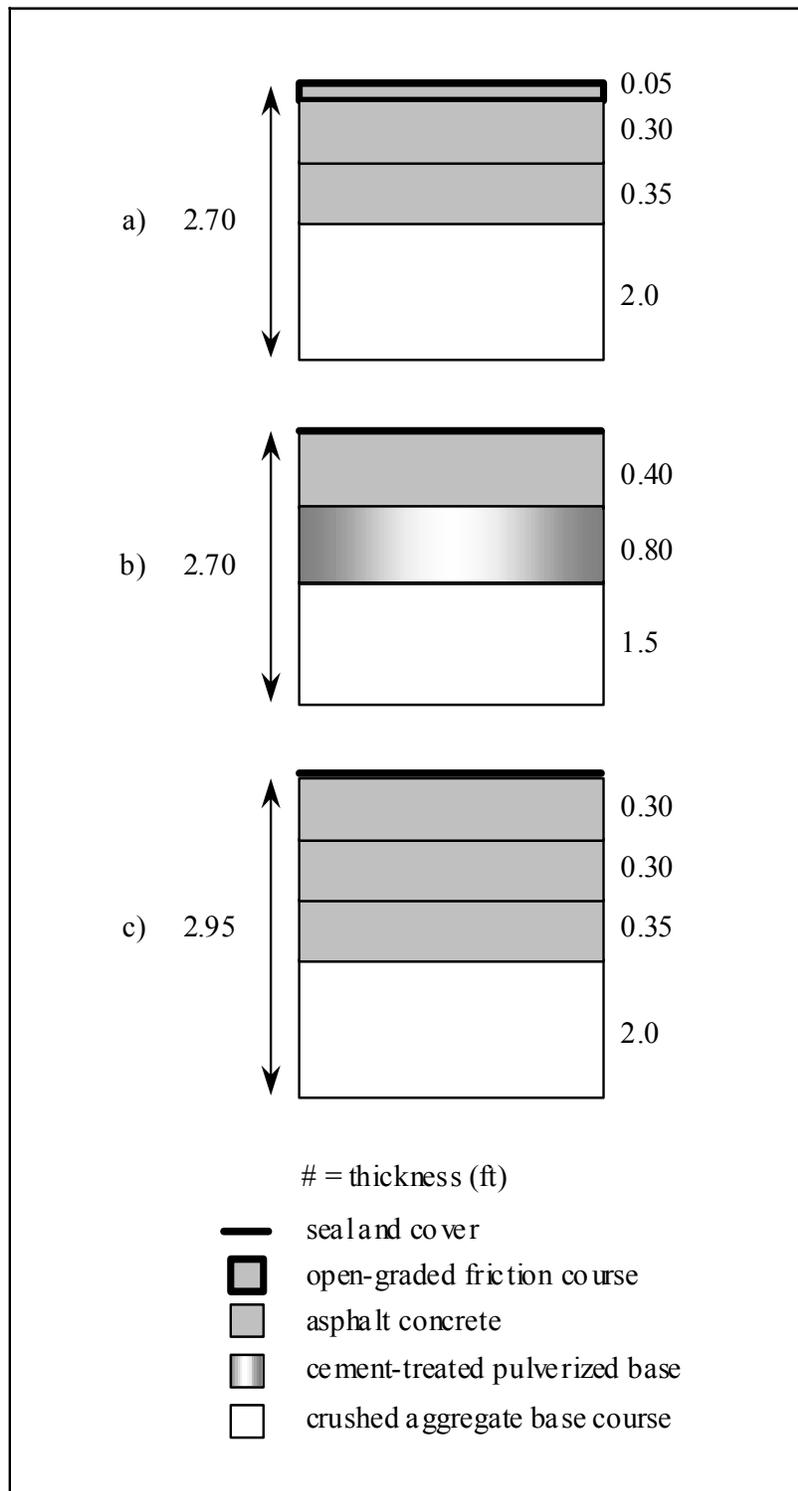
Figure 8. Pavement Cross-Sections at Rocky Canyon:
 a) original pavement, b) control section, and c) test section

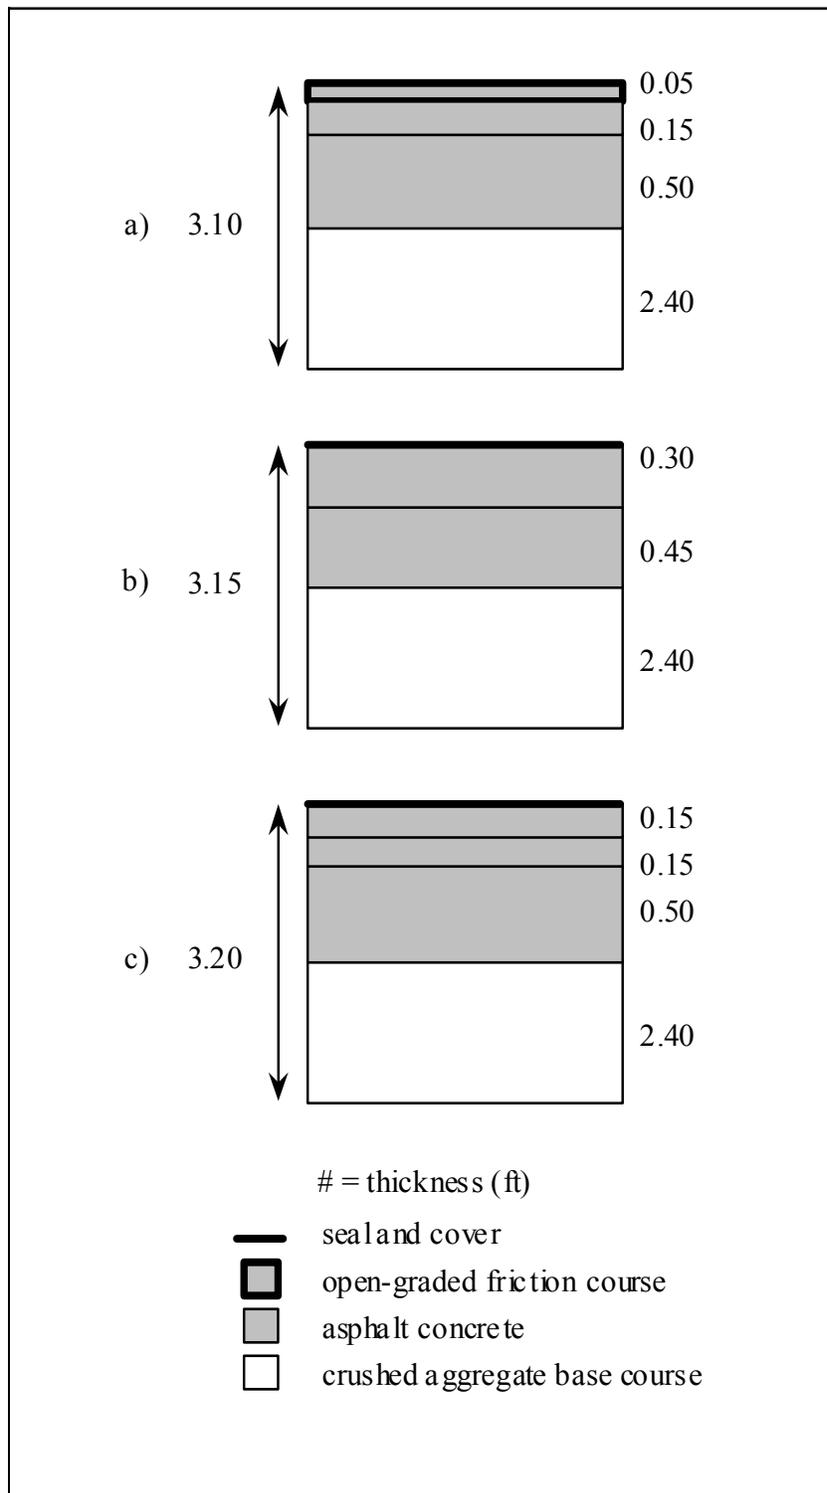
Figure 9. Pavement Cross-Sections at Lincoln Road-Sieben: a) original pavement, b) control section, and c) test section

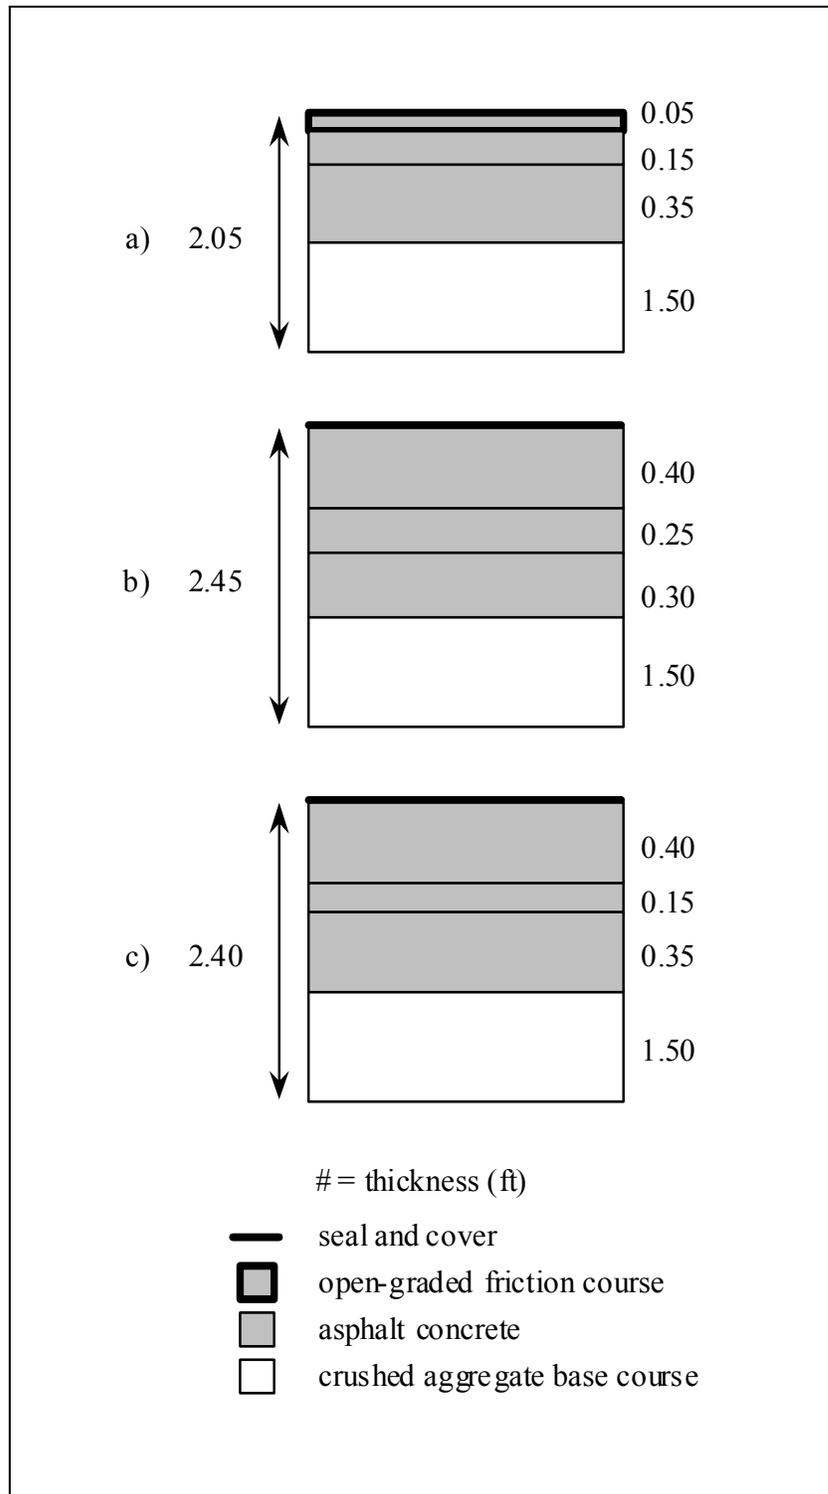
Figure 10. Pavement Cross-Sections at Custer County Line West: a) original pavement, b) control section, and c) test section

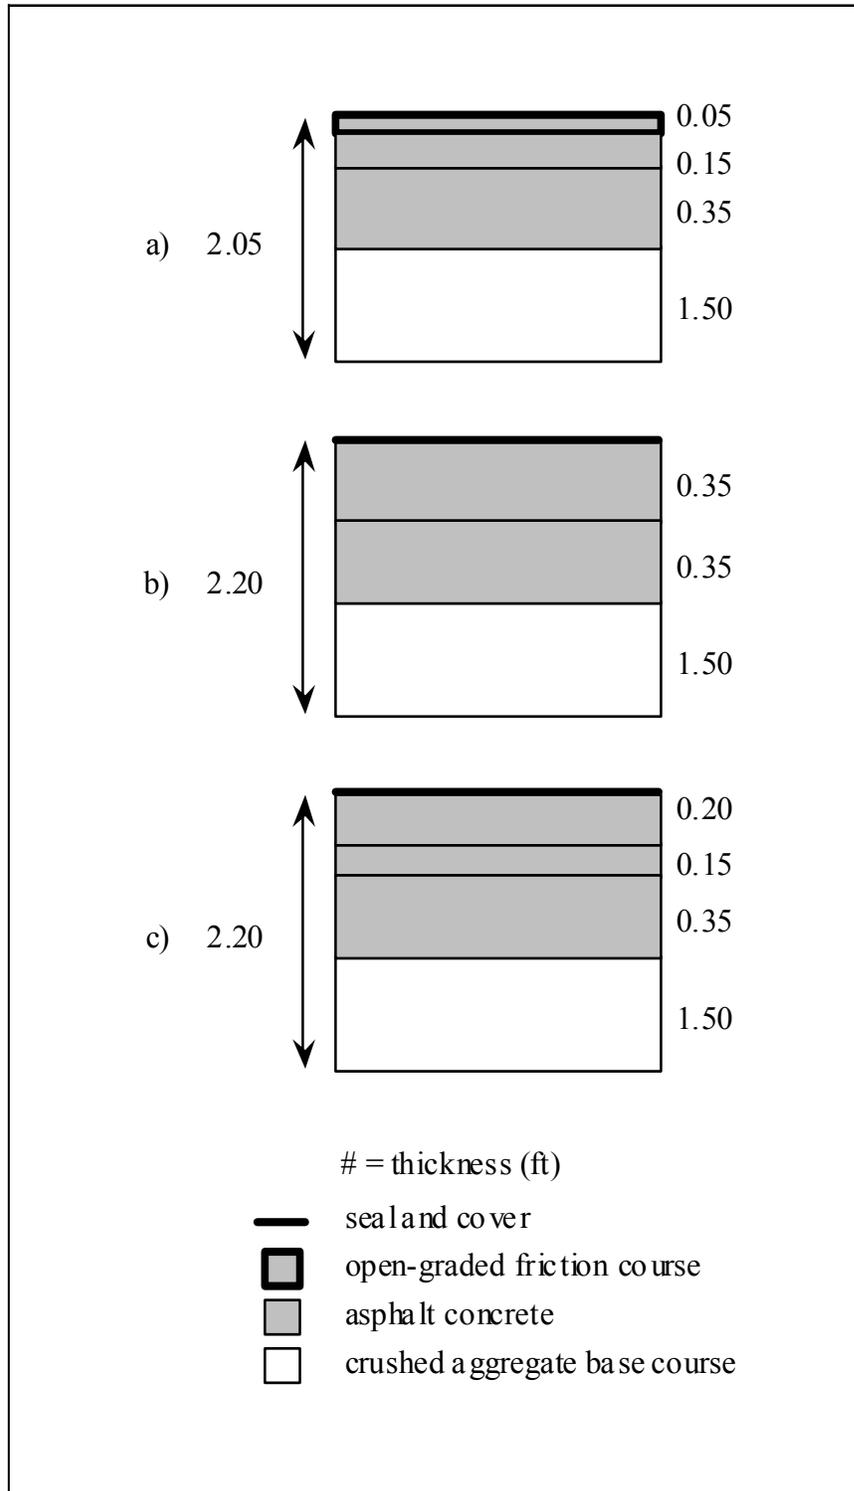
Figure 11. Pavement Cross-Sections at Tarkio-East:
a) original pavement, b) control section, and c) test section

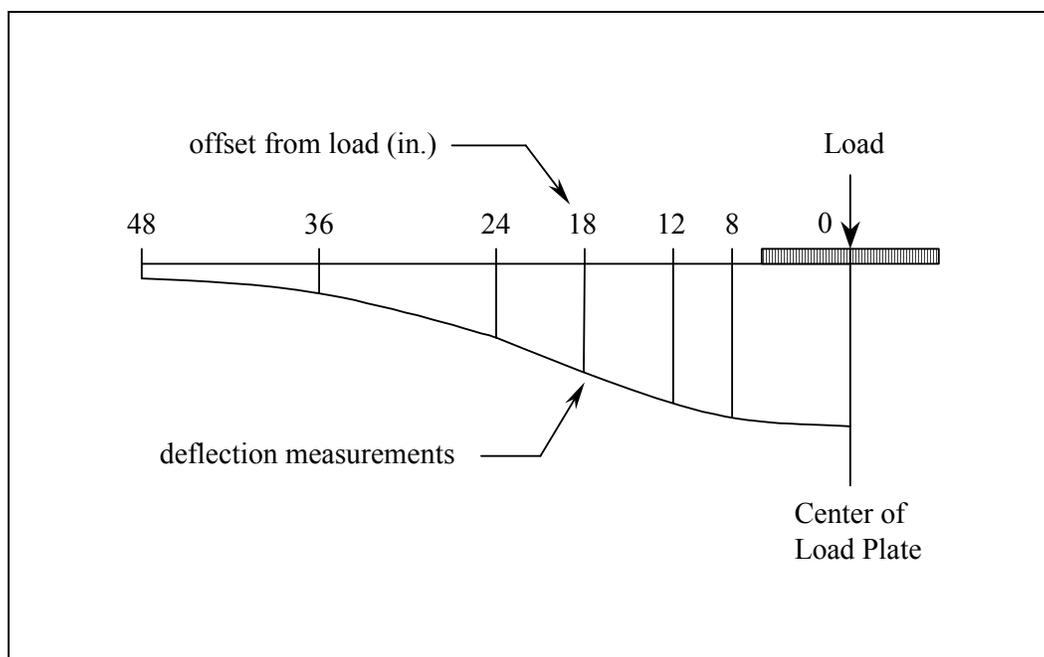
During Road Rater and FWD testing, the applied force and the pavement surface deflections were measured. Surface deflections were measured at the following horizontal offset distances from the load: 0, 8, 12, 18 (FWD only), 24, 36, and 48 inches. MDT retains peak loads and peak deflections for analysis purposes. The peak deflections can be used to produce a “deflection basin,” such as that shown in Figure 12. The deflection basin, in combination with the known load and assumed layer thicknesses, can be used to estimate the elastic moduli of pavement layers. This process is often referred to as “back-calculation” and usually involves the

Figure 12. Deflection Basin Obtained During Road Rater and FWD Testing

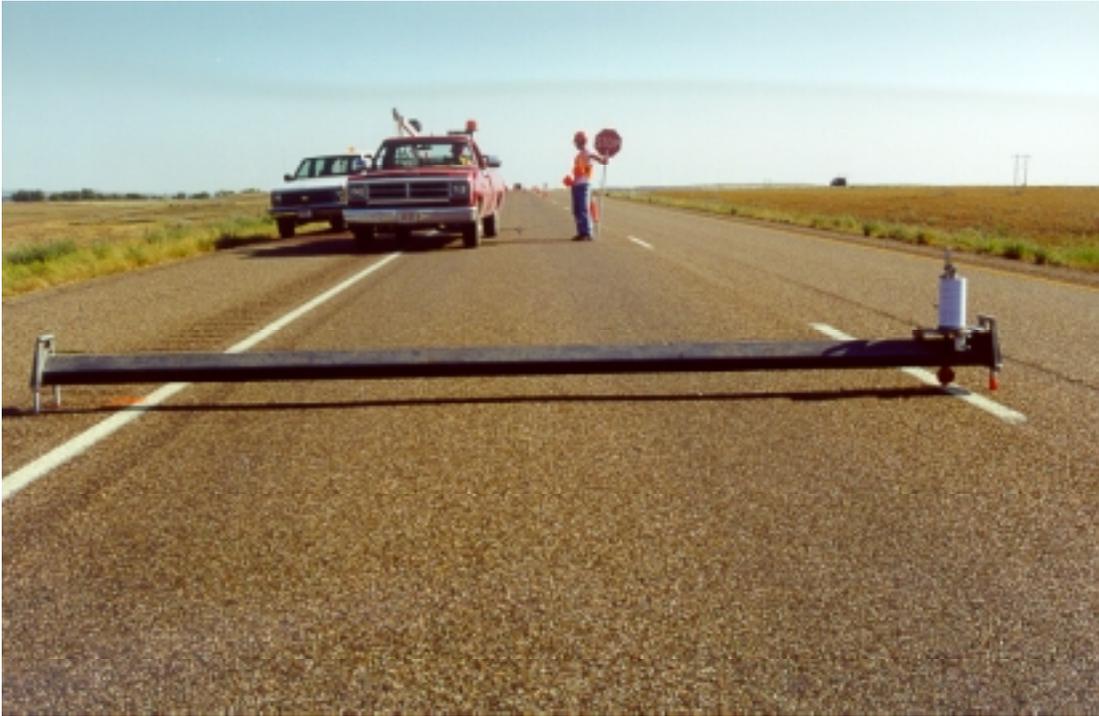
During the last two years of roughness and rut depth monitoring (1999 and 2000), the Rainhart Profilograph was used to measure rut depth because it had demonstrated the ability to supply accurate and reliable data during other recent MDT research studies. The Rainhart Profilograph differs fundamentally from the South Dakota Profilometer because it measures ruts by purely mechanical means. This profilograph consists of a rigid beam, which is supported above the pavement surface by rigid legs. Typically, the beam is positioned transverse to a roadway lane (Figure 13). Upon the beam rests a barrel to which a pen and lined graph paper are attached. As the barrel is moved across the beam, a wheel that rides on the pavement surface transcribes changes in elevation on the paper (Figure 14). The profilograph is placed at discrete locations along the pavement and the surface elevation measurement wheel is moved from one side of a lane to the other. For this research, the wheel was first moved from the shoulder to the centerline. The marking pen was then moved slightly and a second profile of the same station was made from the centerline to the shoulder. Scaling ratios were set so that surface roughness was drawn with a 1:12 ratio (paper:pavement) horizontally and a 1:1 ratio vertically.

Figure 13. Rainhart Profilograph

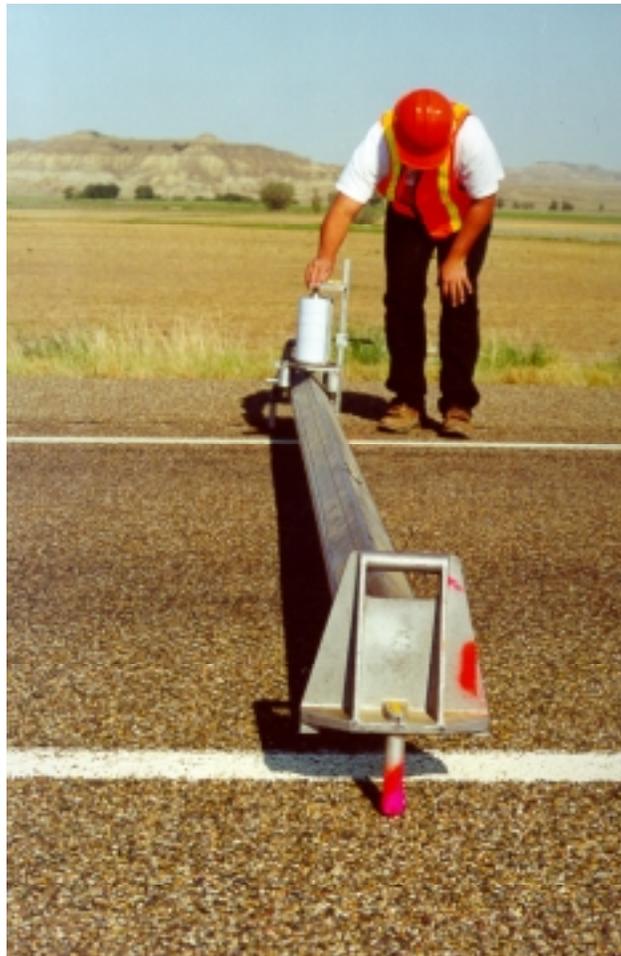
Figure 14. Moving the Rut-Transcribing Mechanism Across the Rainhart Profilograph

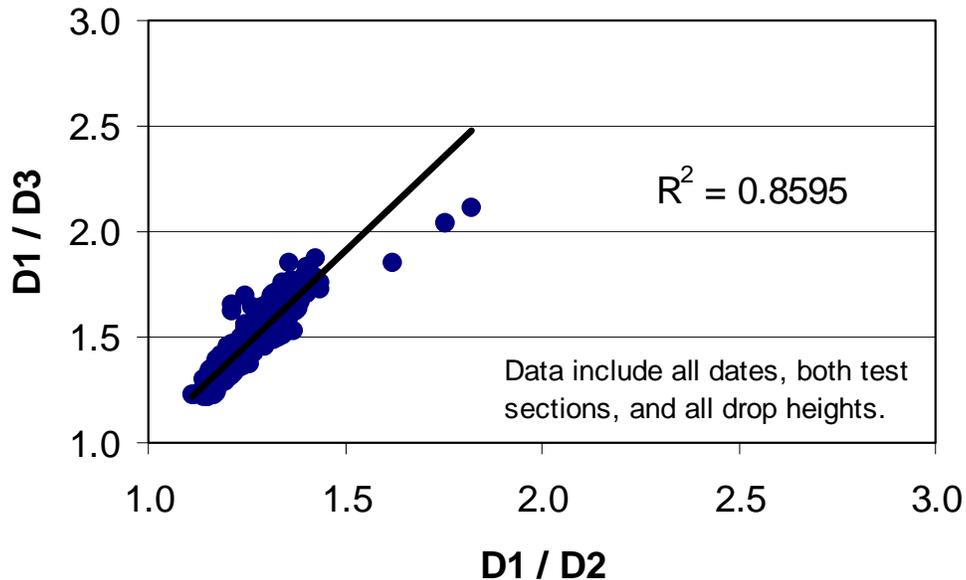
The Lincoln Road data was used to develop a routine of data analyses. Only one of the basin curvature parameters was found to be necessary because they were highly correlated with a Pearson correlation coefficient equal to 0.927 (see Figure 15). The D1/D3 parameter was chosen because its use is popular and well documented (e.g. Rohde 1990). Further references to basin curvature will imply the D1/D3 parameter.

Figure 15. Correlation of Basin Curvature Parameters for Lincoln Road-Sieben Site

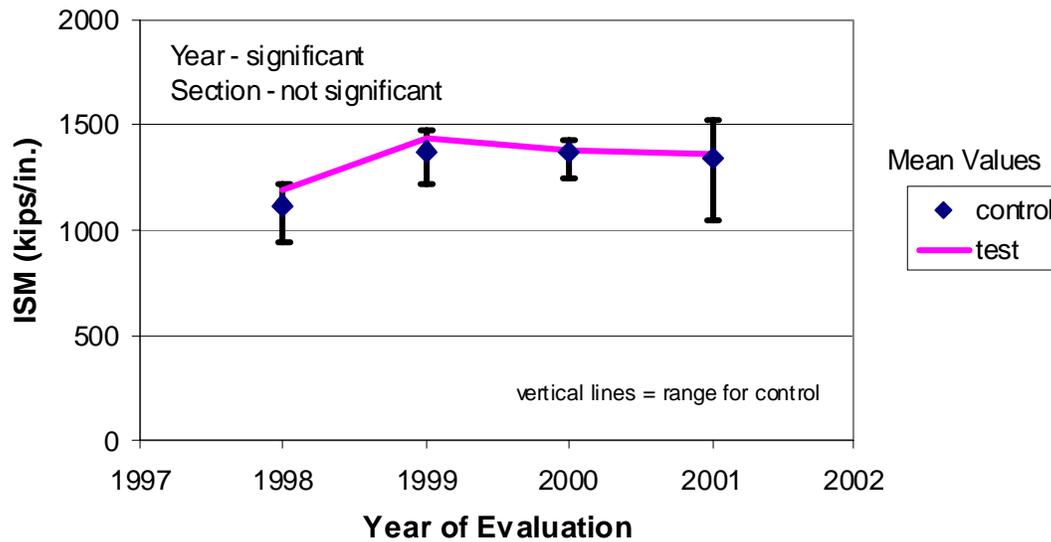
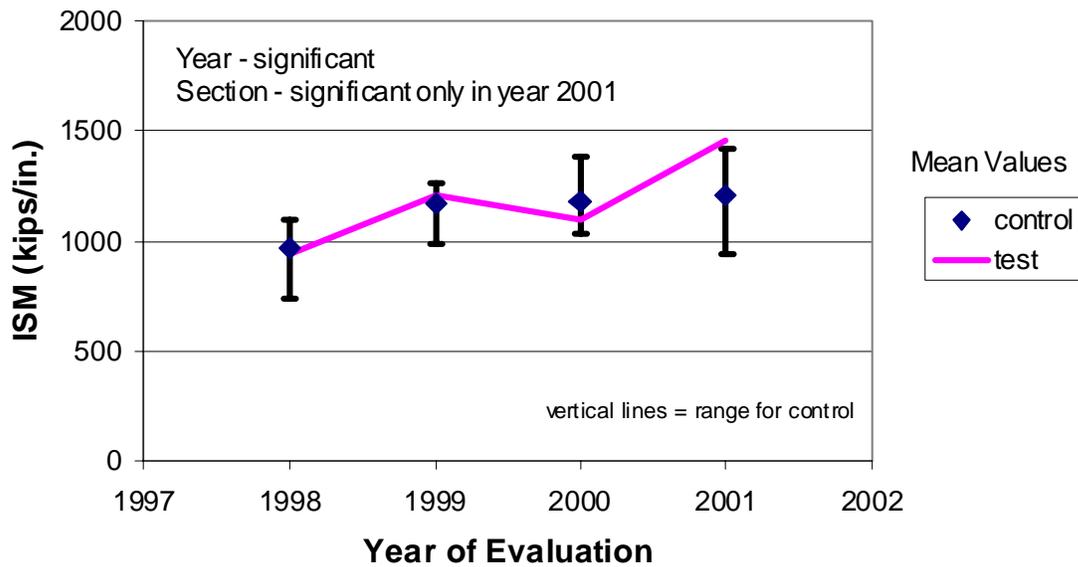
Mean values for ISM for both control and test sections on all FWD test dates are shown in Figures 16 through 21. The range of values for each evaluation of the control section is also shown to provide an indication of data scatter. In each figure, "year" and "section" are each labeled as either significant or non-significant in terms of their effects on the dependant variable (ISM or basin curvature). Significance was gleaned from the statistical tests. For the two-factor analyses of variance, a source of variation was considered significant if the null hypothesis (i.e. equal treatments) could be rejected with a probability of error less than 5 percent. Because the one-way analyses of variance and the Student's t-tests were performed simultaneously, a source of variation was considered significant only if the null hypothesis could be rejected with a probability of error less than 1 percent. This imposed conservatism on each test was necessary to achieve an appropriate experiment-wise error rate.

Figure 16. Impulse Stiffness Modulus at Bearmouth Drummond, Westbound Lane

Figure 17. Impulse Stiffness Modulus at Bearmouth Drummond, Eastbound Lane

For each test site, ISM changed significantly with time (different evaluation dates). In most cases, the trend was toward increasing stiffness. However, pavement stiffness at Custer County decreased steadily from 1999 to 2001. For each test site, except for Bearmouth Drummond Westbound and Rocky Canyon, ISM was significantly different between pavement sections (i.e. control versus test). At Bearmouth Drummond Eastbound, the test section showed a relatively high ISM in the year 2001 (see Figure 17). However, the control had not decreased from its year 2000 measurements. At each of Lincoln Road, Custer County, and Tarkio East, the test sections were slightly less stiff than the control sections (see Figures 19 through 21).

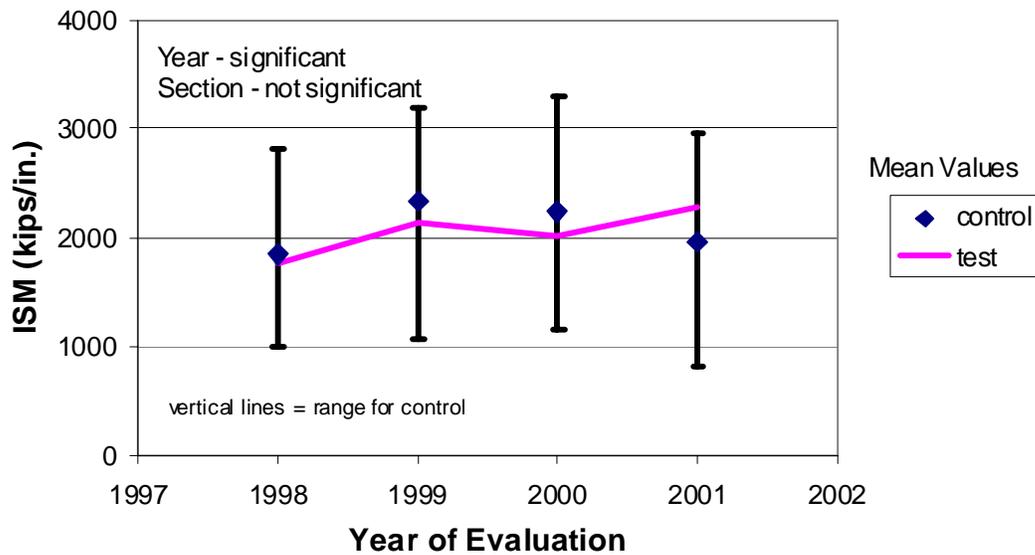
Figure 18. Impulse Stiffness Modulus at Rocky Canyon

The high variability in ISM for the control section at Rocky Canyon is interesting (see Figure 18). Rehabilitation of this pavement included the placement of 9.6 in. of cement-treated pulverized base (CTPB). The variability in ISM may be a reflection of spatial variability in the strength attained in the CTPB.

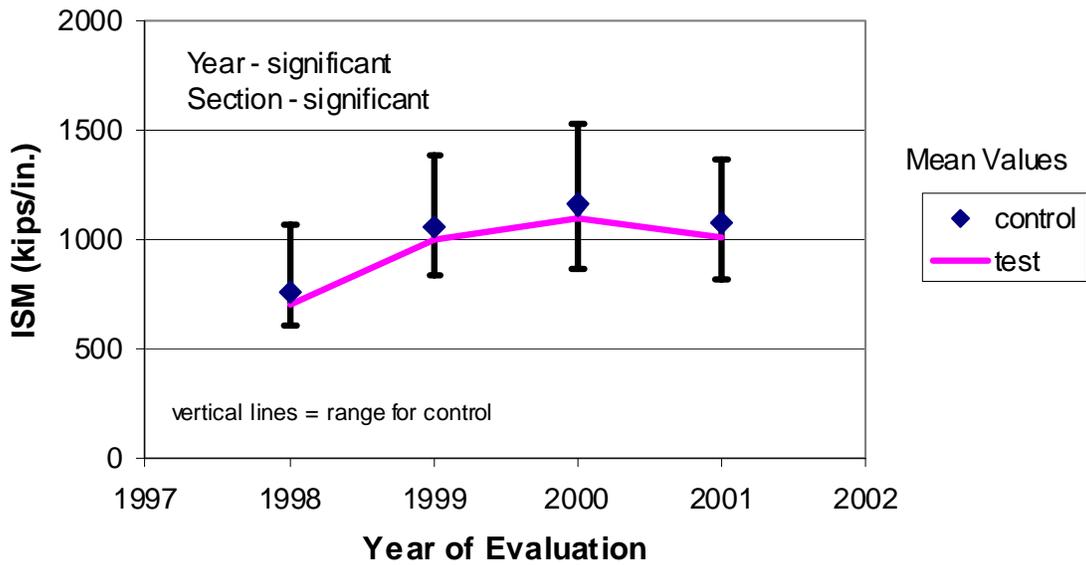
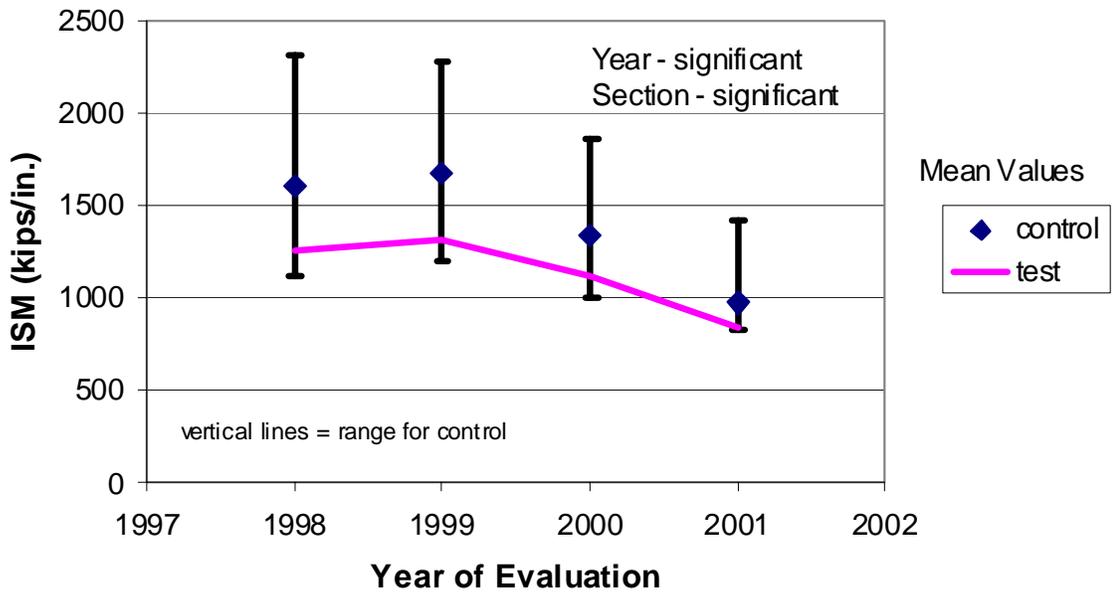
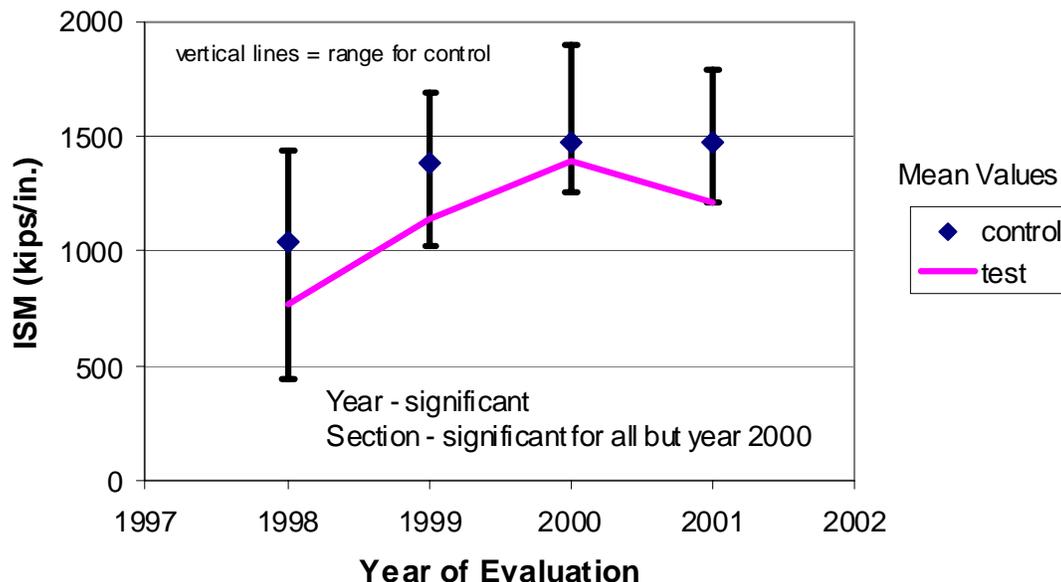
Figure 19. Impulse Stiffness Modulus at Lincoln Road

Figure 20. Impulse Stiffness Modulus at Custer County Line

Figure 21. Impulse Stiffness Modulus at Tarkio East

However, these differences did not change over time. These differences should therefore be considered as reflections of different pavement cross-sections, rather than as reflections of the durability of different rehabilitation techniques.

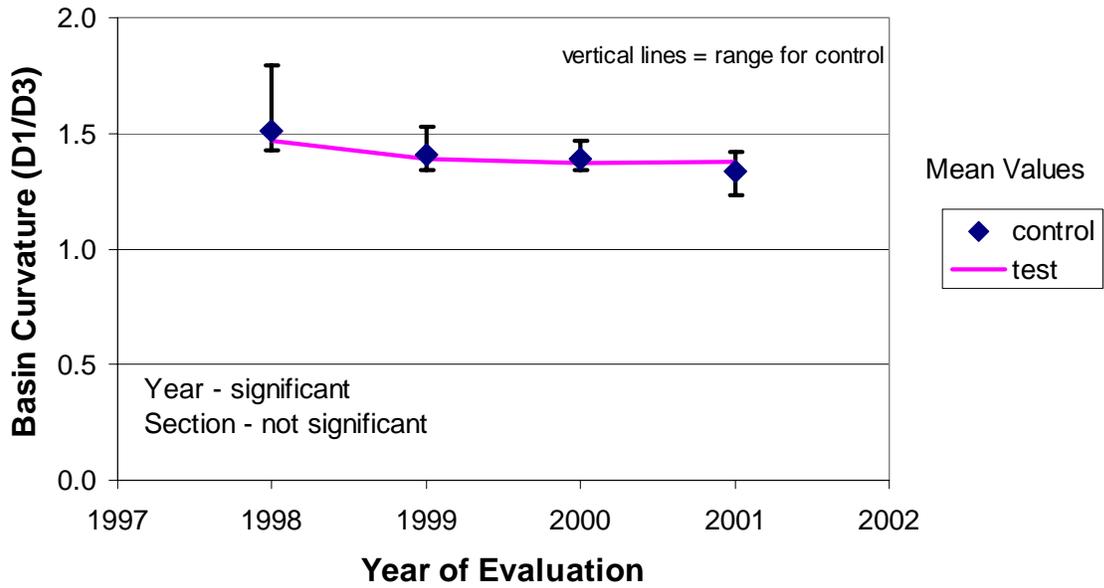
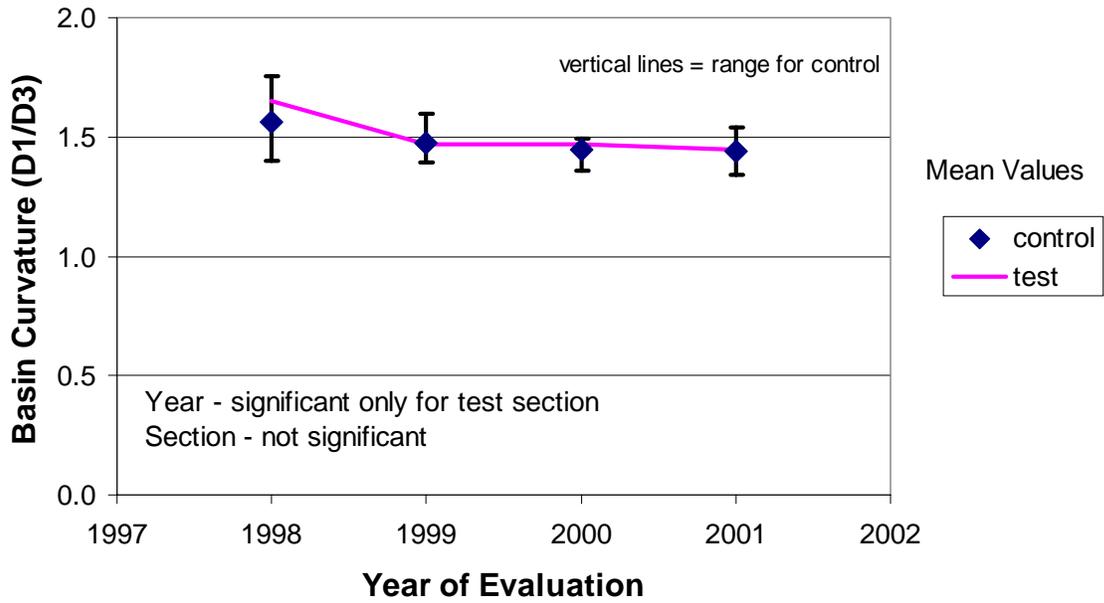
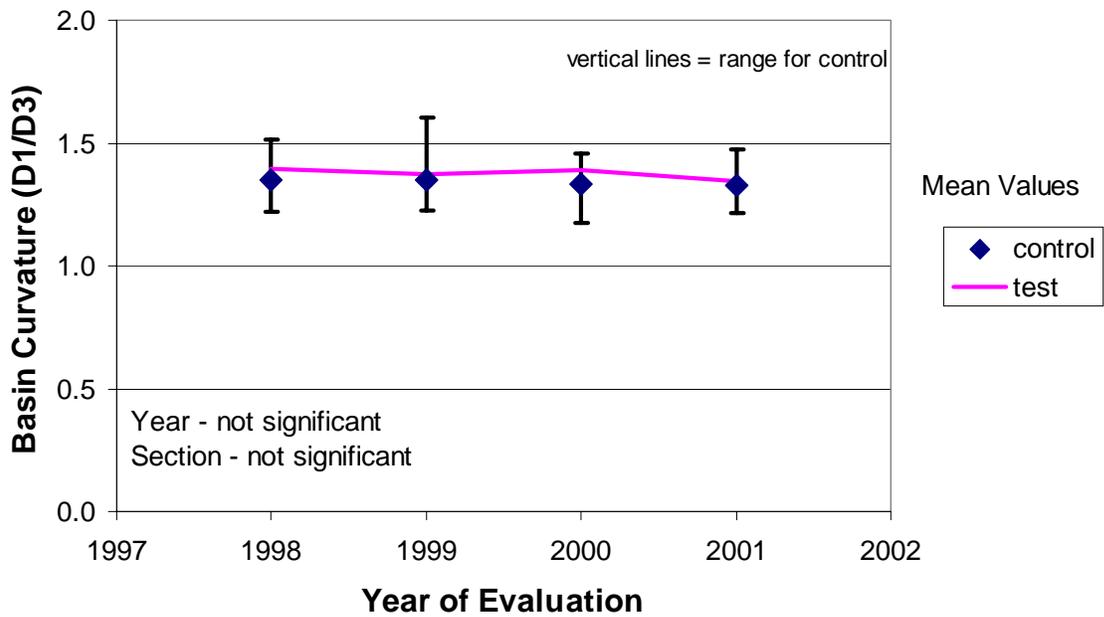
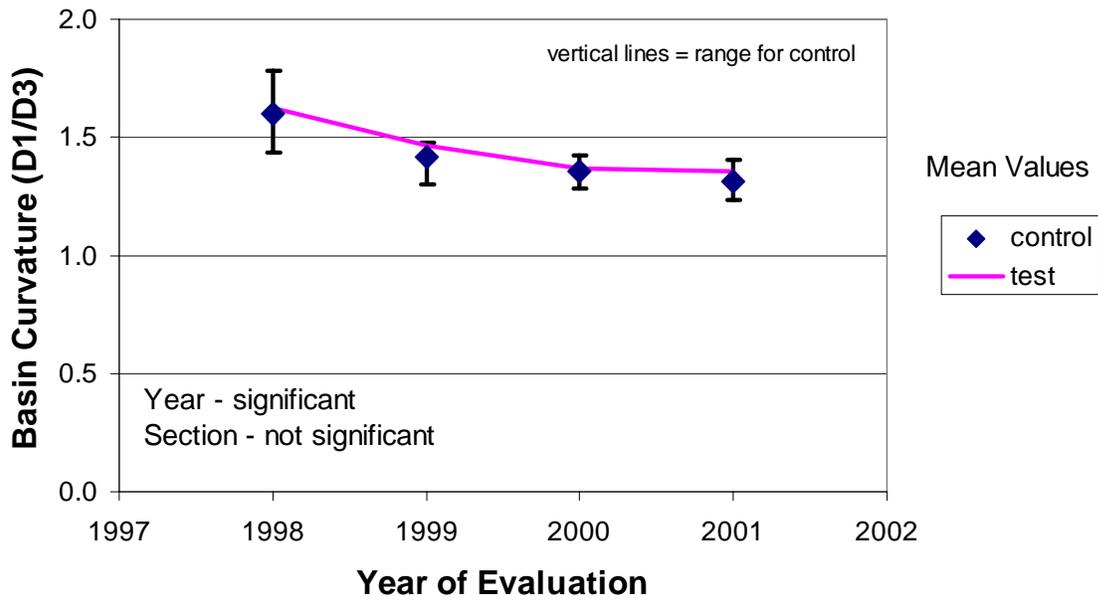
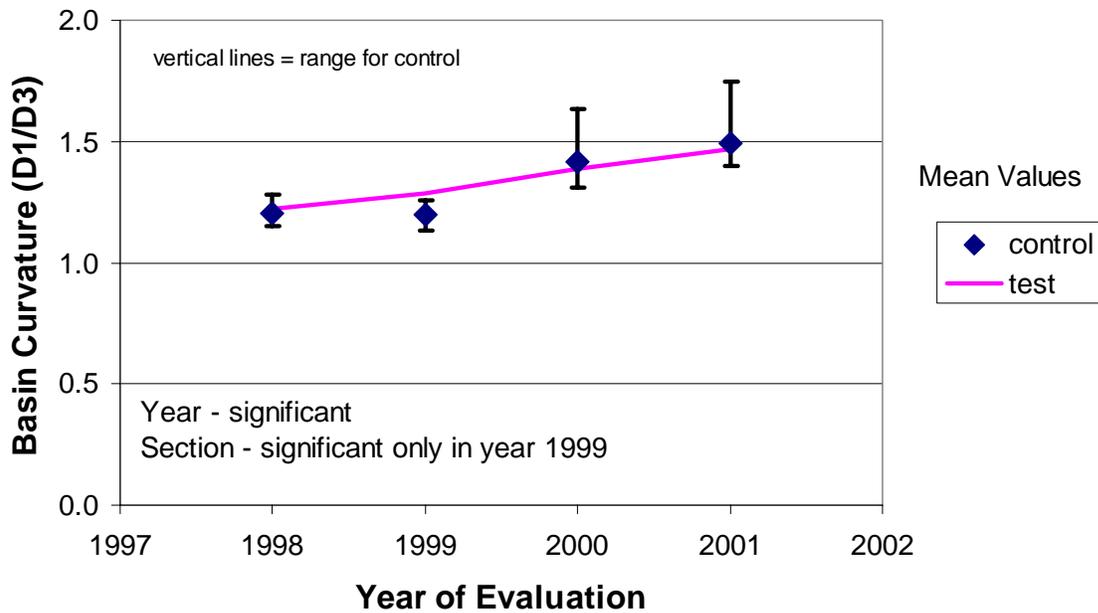
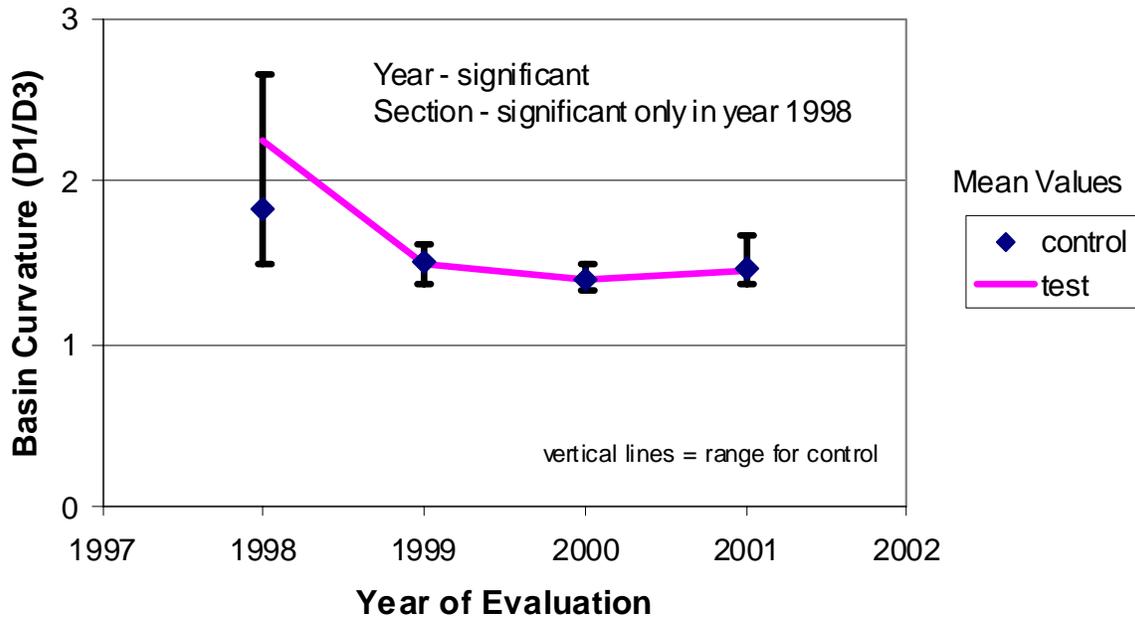
Similarly, basin curvature generally changed significantly over time. In most cases, the trend was toward increasing pavement stiffness (see Figures 22 through 27). Custer County was the only test site where curvature increased over time, indicating a weakening of near-surface pavement layers (see Figure 26). This weakening was consistent with ISM results. Differences between control and test sections were not significant.

Figure 22. Basin Curvature at Bearmouth Drummond, Westbound Lane

Figure 23. Basin Curvature at Bearmouth Drummond, Eastbound Lane

Figure 24. Basin Curvature at Rocky Canyon

Figure 25. Basin Curvature at Lincoln Road

Figure 26. Basin Curvature at Custer County Line

Figure 27. Basin Curvature at Tarkio East
